**SIDE-CHANNEL SPILLWAY AND OUTLET  
WORKS FOR SAN ANTONIO DAM**

Hydraulic Model Investigation

Report No. 2-106  
October 1978

U. S. Army Engineer District, Los Angeles  
CORPS OF ENGINEERS  
Los Angeles, California

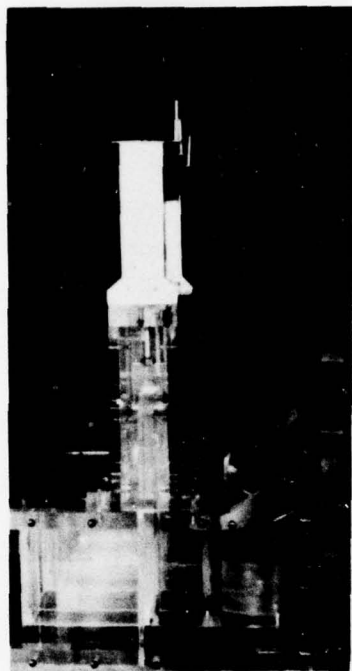
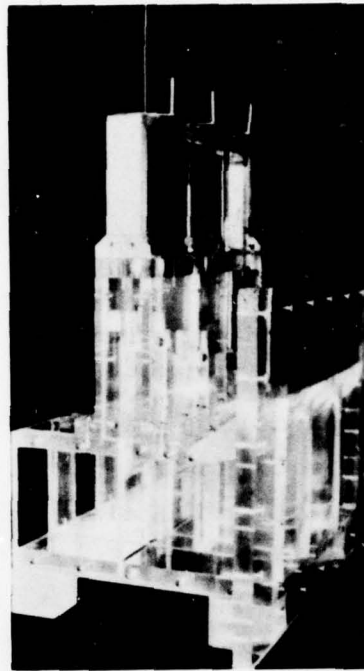
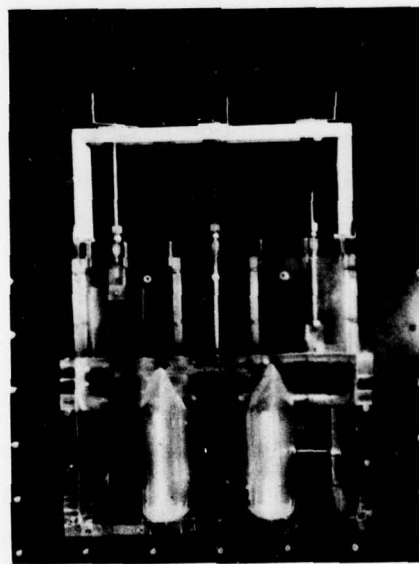
Figure 1. 1:20-scale intake structure

Side views

Downstream view

15. The model of the outlet works was constructed to a scale ratio of 1:20. Tests were divided into two general phases: (a) the intake structure and (b) the transition and circular conduit. Figures 1, 2, and 3 show the intake structure and component parts of the outlet works. Details also are shown in Plate 9. Flow from the intake structure is regulated by three vertical slide gates and discharged into three separate passages in the transition. Observations of flow

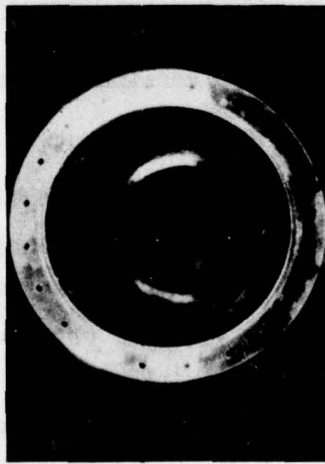
Figure 2. Components of outlet works

Upstream end view of transition

End view of circular conduit

a b c

- a. Trifurcated transition (rectangular to octagonal)
- b. Transition (octagonal to circular)
- c. Circular conduit

Composite transition

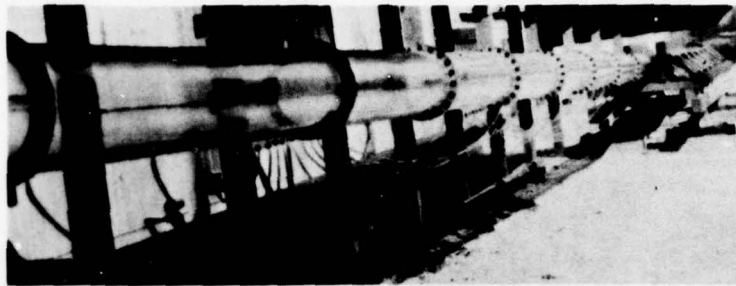
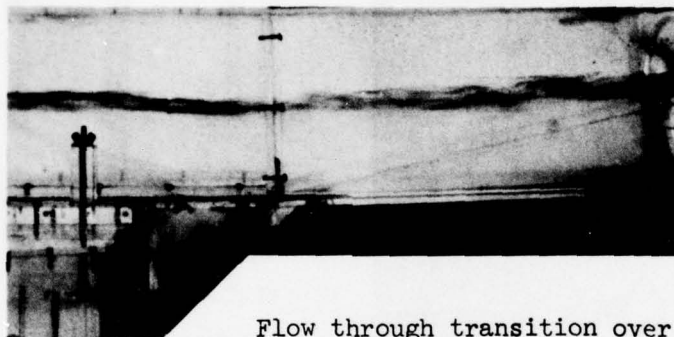
Figure 3. Outlet works

Outlet conduit

Flow through transition over  
diversion structure

Diversion structure

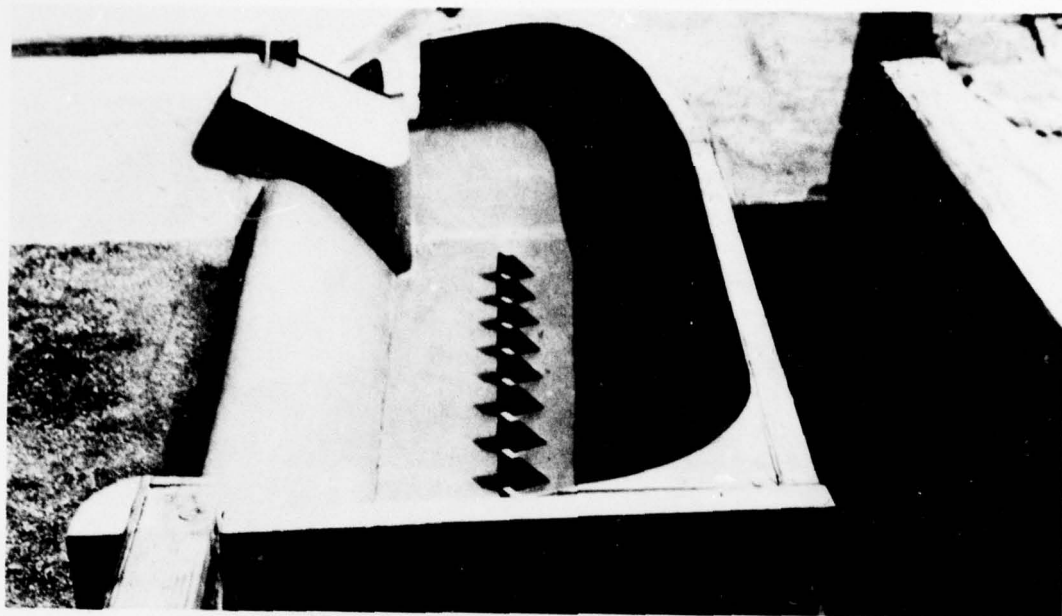
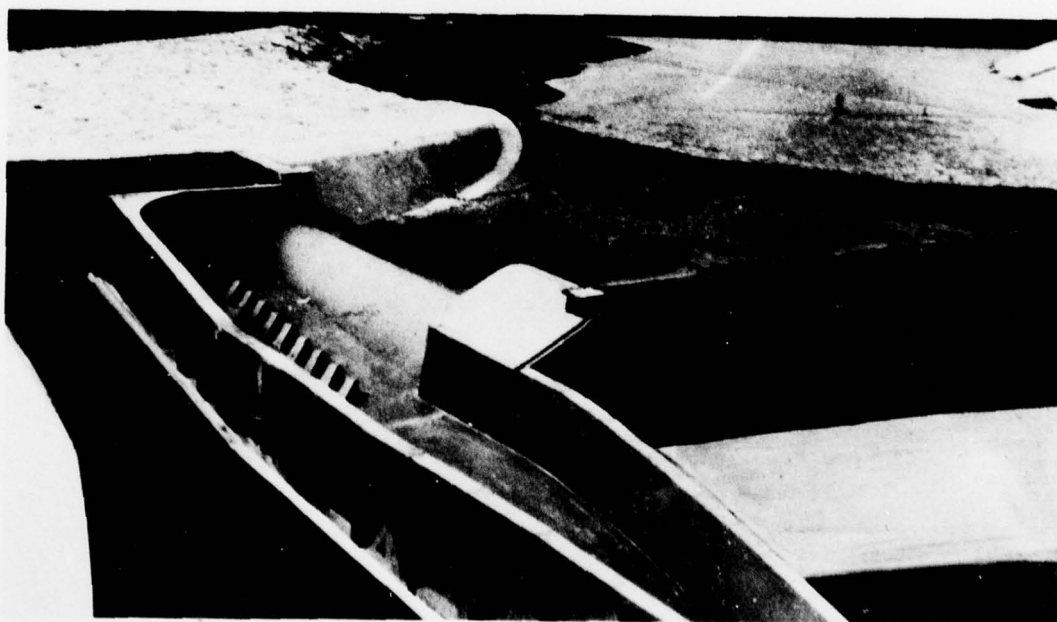
Photo 1. Final design, 1:36-scale model (sheet 1 of 2)

a. Downstream view of spillway channel

b. Upstream view

11. The first model was constructed to a scale ratio of 1:36 to simulate the spillway crest and the side-channel spillway (Photo 1). Details of the spillway crest are shown in Plate 3. No alterations were made to the spillway crest during the model studies. It was previously mentioned that the spillway crest was designed to pass 54,000 cfs under a head of 17.0 ft. Test results indicated that although flow distribution in the upstream approach and at the spillway was satisfactory, flow in the side channel needed improvement. Excessive ride-up occurred on the vertical outer wall, and the flow was very turbulent and unstable in the side channel. Further tests conducted with the addition of baffle blocks on the side-channel invert indicated a much improved flow condition. The ride-up was reduced by about 5 ft, and the flow in the side channel was more stable and less turbulent (Photo 2). Longitudinal water-surface profiles within the side channel for a discharge of 54,000 cfs are shown in Plate 4.

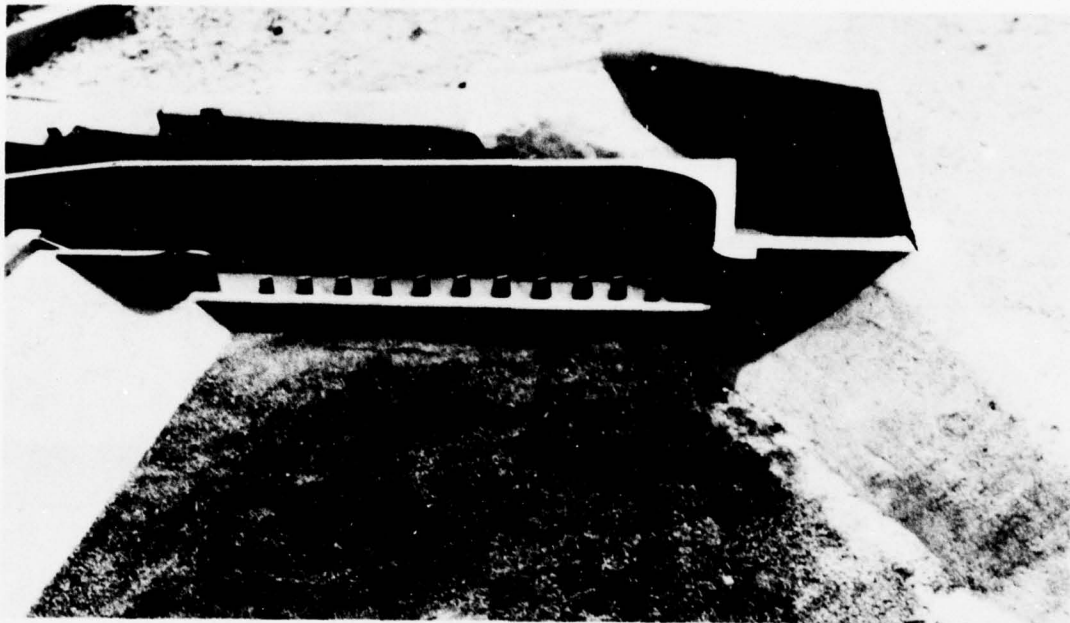
Photo 1 (sheet 2 of 2)

c. Approach to spillway crest, looking downstream

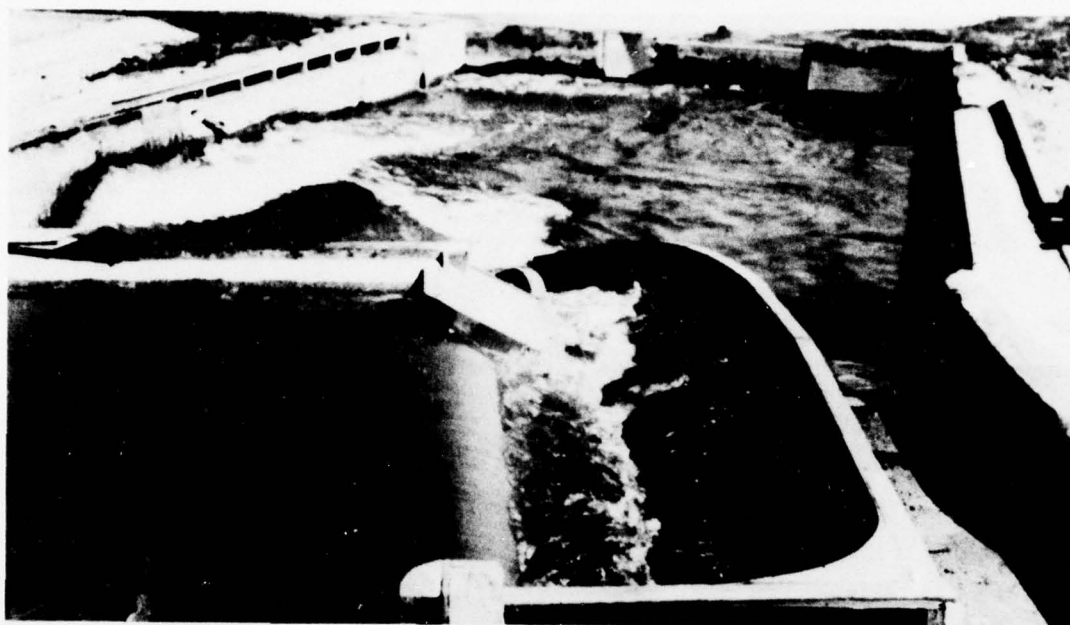
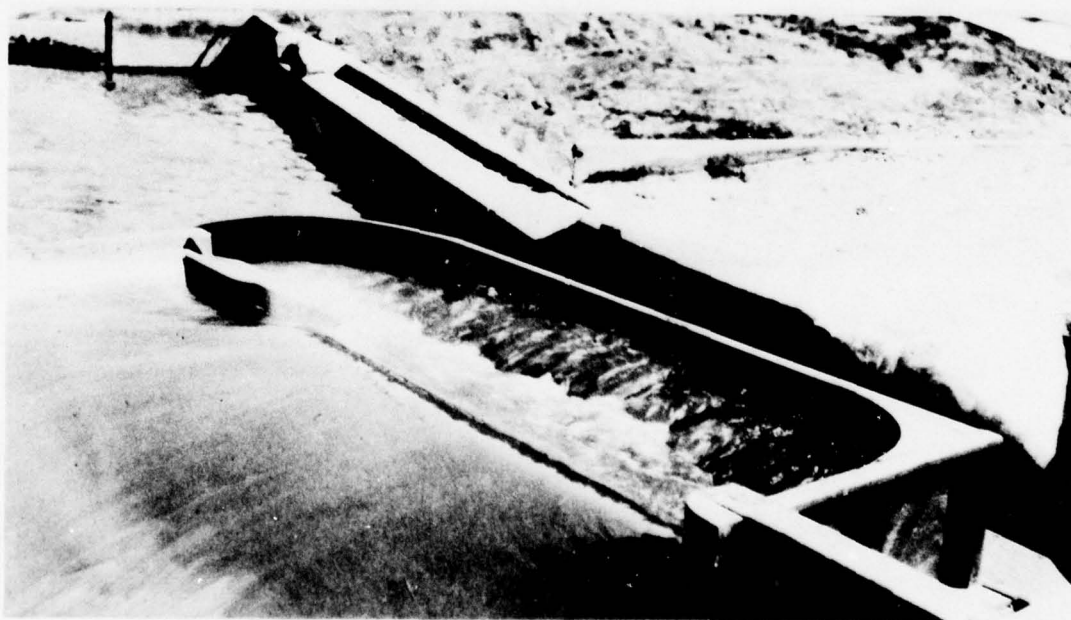
Photo 2. Final design flow conditions, 1:36-scale model,  
discharge 54,000 cfs, downstream views

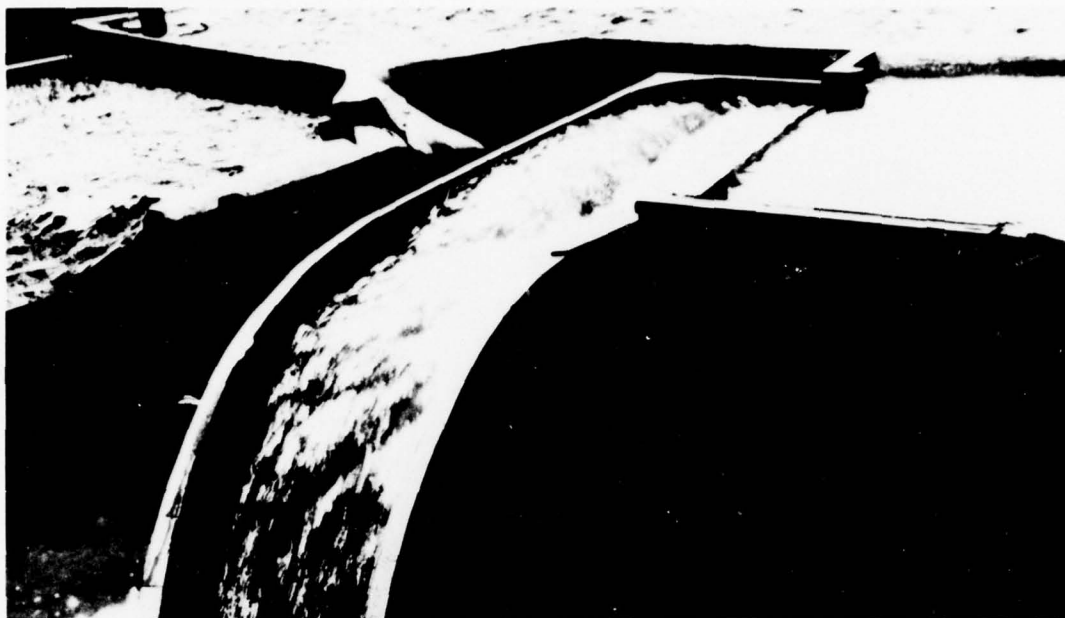
Photo 4. Final design flow conditions, 1:48-scale  
model, discharge 54,000 cfs

a. Upstream view

b. General view

14. The model was tested for a discharge of 54,000 cfs, the results of which are shown in Photo 4. As previously mentioned, some improvement in the conditions of flow in the side channel was effected by the baffle blocks; however, the flow became more stable through as well as downstream from the curved transition. The water-surface profiles measured along both the right and left walls of the chute are shown in Plate 7. The profiles indicate that the wall heights provided adequate freeboard to confine the flow. The water-surface cross sections from sta 9+50 to sta 11+95.49 for a discharge of 54,000 cfs are presented in Plate 8.

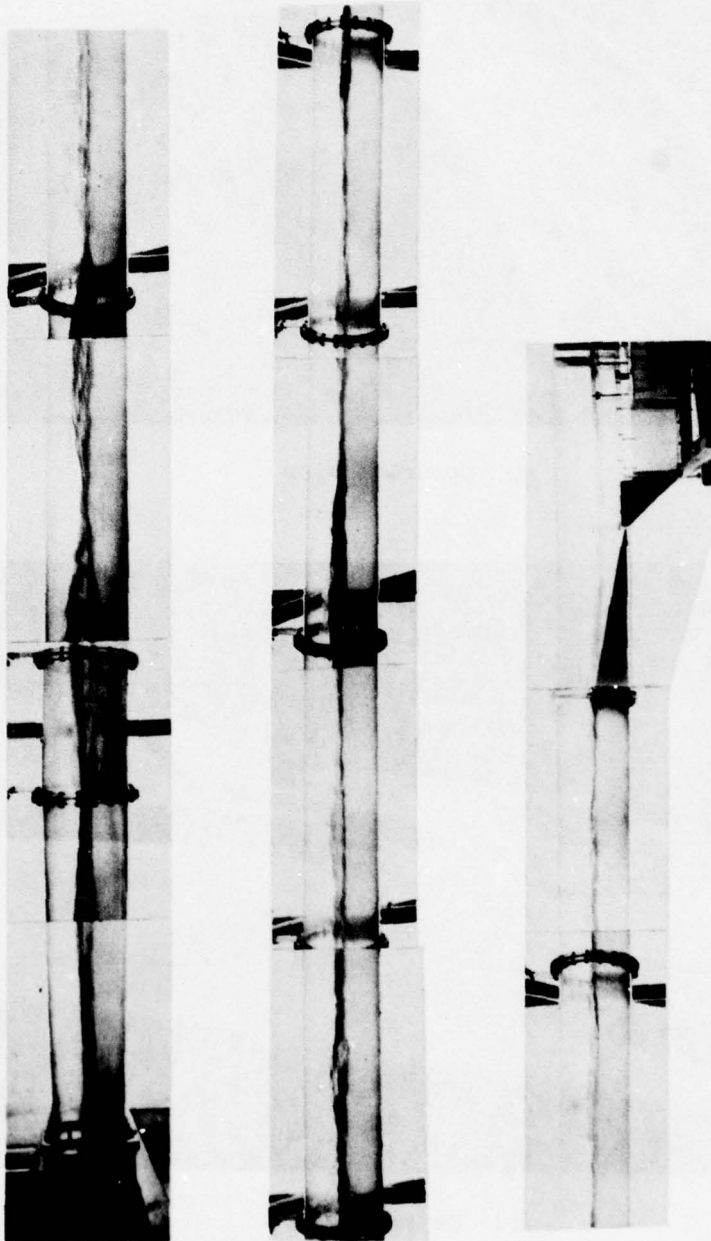
Photo 5. Flow conditions in outlet works, 1:20-scale model;  
discharge 5,000 cfs and gate openings 6.0 ft

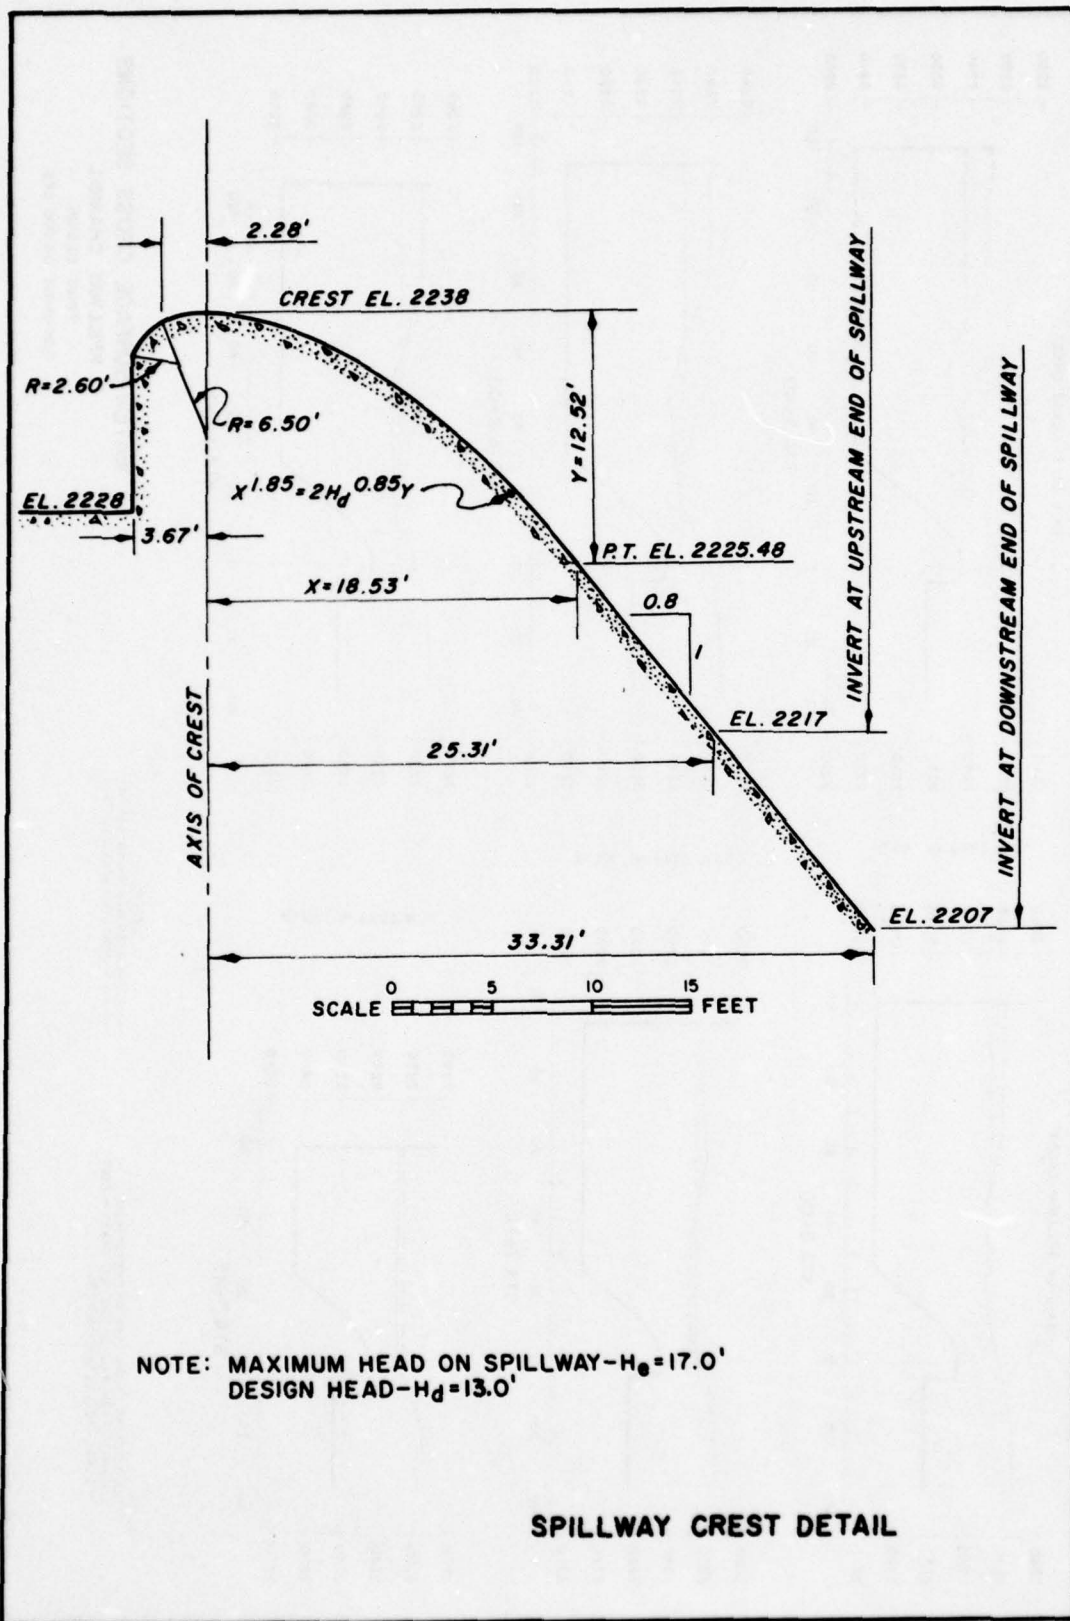
SPILLWAY CREST DETAIL

NOTE: MAXIMUM HEAD ON SPILLWAY- $H_0=17.0'$   
 DESIGN HEAD- $H_d=13.0'$

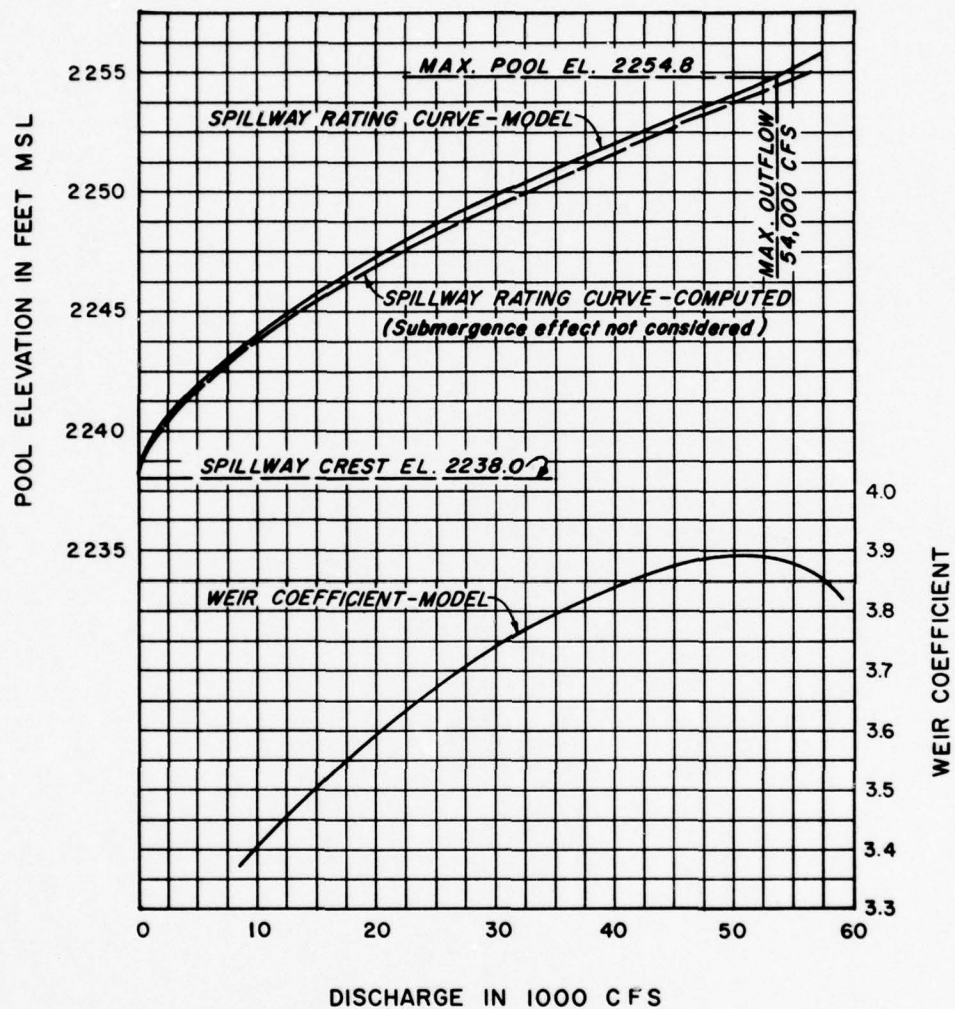
### SPILLWAY RATING CURVE

NOTE: MODEL COEFFICIENT "C" COMPUTED FROM  
 FORMULA,  $Q = CLH^{3/2}$   
 L=200.0 FEET, LENGTH OF SPILLWAY CREST  
 H=HEAD ON SPILLWAY CREST

12. The spillway crest was calibrated for heads up to 17 ft. The spillway discharges versus reservoir elevations are shown in Table 1. Plate 5 shows the rating curves, one computed and the other determined from the model data. Computed head-discharge relations conformed very closely to values that were observed in the model. Also shown in Plate 5 is the discharge-coefficient curve, computed from the model data by the use of the formula

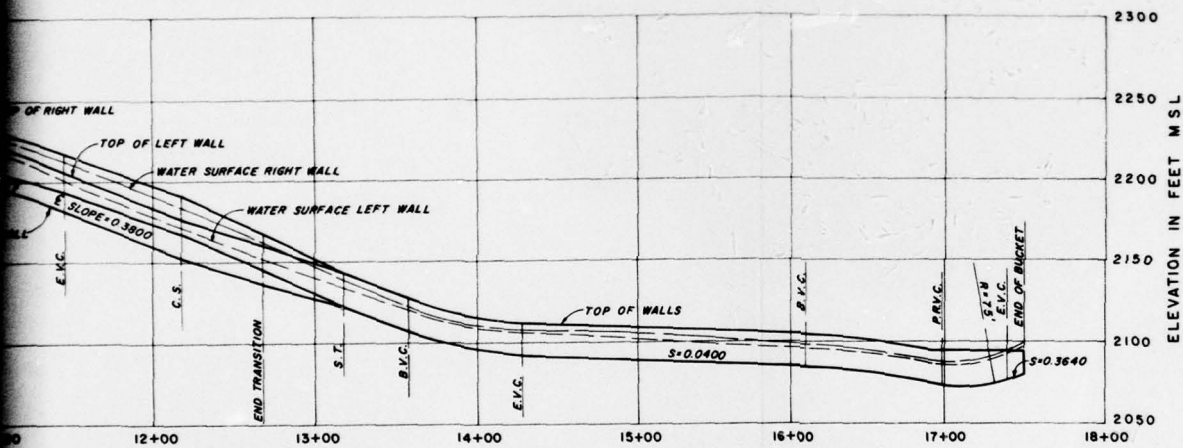
**WATER-SURFACE PROFILES**  
FINAL DESIGN

# **WATER-SURFACE PROFILES**

DISCHARGE 54,000 CFS

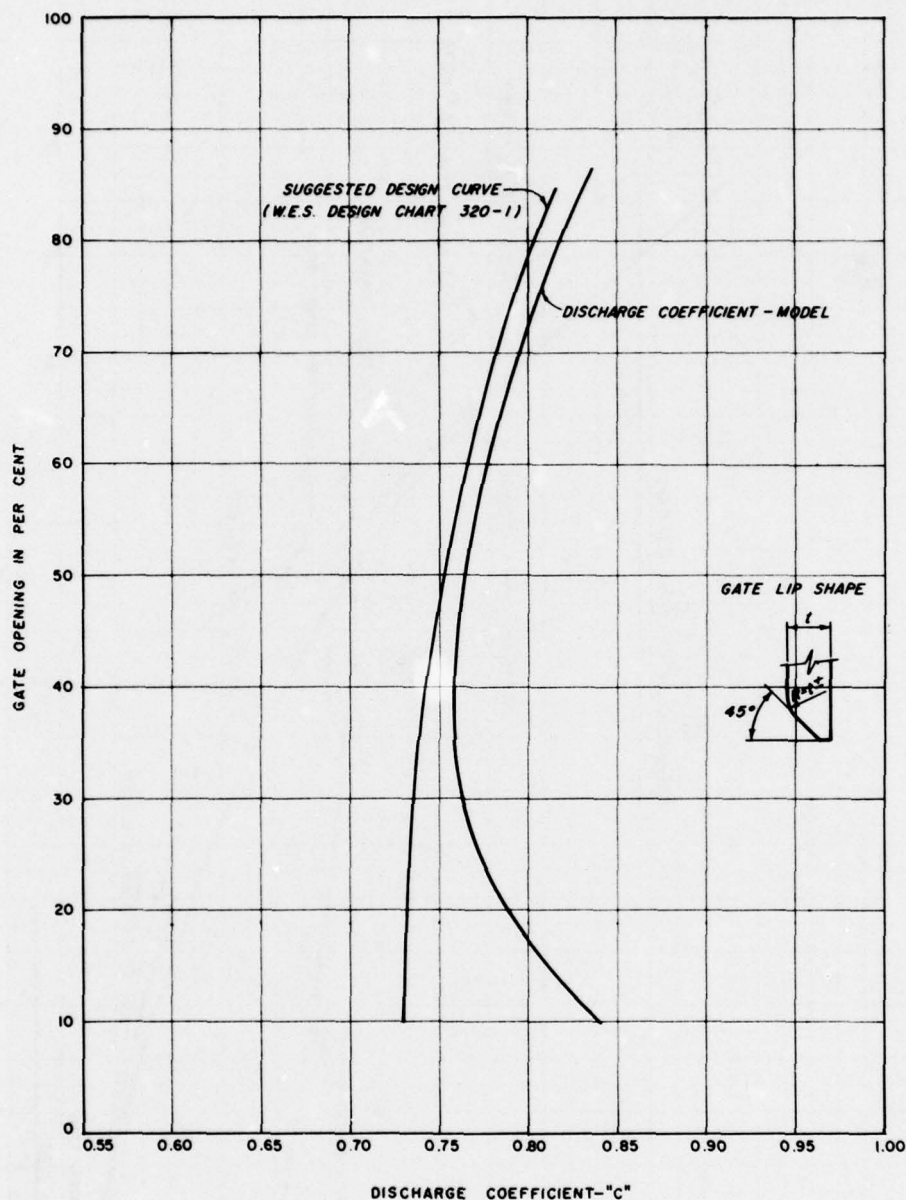
CONTROL GATES  
 DISCHARGE COEFFICIENT  
 FOR PARTIAL GATE OPENING

1. THREE GATES WITH EQUAL OPENING.
2. WIDTH OF EACH GATE, 5'-8".
3. COEFFICIENT PLOTTED IS AVERAGE VALUE OF EACH GATE OPENING.
4. "C" COMPUTED FROM FORMULA  
 $Q = CA \sqrt{2gH}$ , WHERE H = DIFFERENCE BETWEEN POOL ELEVATION AND TOP OF OPENING.

with all gates opened 8.5 ft and pool el of 2,206.5 ft. Open-channel flow with surges occurred in the model outlet conduit. A calibration test was made on the three gates to determine the coefficients of discharge of various but equal gate openings. These data provided a comparison of the model operation with the suggested design curve (WES HDC chart 320-1\*). Comparisons of the suggested and measured coefficient data are shown in Plate 10. Photo 5 shows the flow conditions for a discharge of 5,000 cfs and gate openings of 6.0 ft. Observations were also made of flow conditions in the transition and circular conduit for the following gate operations: (a) outer gates opened and center gate closed, (b) outer gates closed and center gate opened, and (c) all gates fully opened. Results of these observations are discussed in the following paragraph.

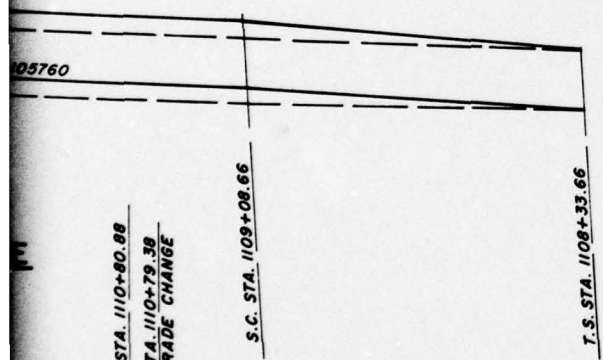
**DIVERSION CHAMBER SECTIONAL PLAN**

**SECTION A-A**

**SECTION D-D**

**WATER CONSERVATION DIVERSION STRUCTURE  
PLAN, PROFILE, AND SECTIONS**

18. Finally, attention was turned to the diversion structure proper. The model was constructed and tested at various locations along the outlet channel. Although provision was made in the model for the construction of the outlet channel at the downstream end of the diversion structure, this feature was used but not tested because the relatively small flows used in testing the diversion structure did not have any effect on the hydraulic performance of the outlet channel design; therefore testing was limited to the diversion structure. The final location recommended for the diversion structure was at the downstream end of the circular conduit. A transition, from a semicircular invert to a rectangular section, joins the conduit to the diversion structure. Details of the diversion structure and portion of the outlet channel are shown in Plate 12. The diversion structure was designed to carry a flow discharge of 1,000 cfs. The diversion flow was regulated by six vertical gates, two gates in the right wall and four gates in the left wall, and discharged into separate spreading grounds located on each side of the outlet channel.

19. The hydraulic characteristics of the structure were observed for various discharges and gate openings, either on one or both sides of the diversion chamber. The discharge to each spreading ground was measured volumetrically. With all gates open and a discharge of 1,000 cfs, the slotted invert into the diversion chamber accommodated all the flow without any interference. Results of the tests indicated that the structure satisfactorily diverted the desired amount of water to the spreading grounds. A discharge of 300 cfs was measured through the right side (two gates) and 700 cfs through the left side (four gates). The model was then tested for incremental discharges up to the maximum capacity of 11,000 cfs to determine if splashing would occur on the downstream leading edge of the slot. Under high heads, the pileup of water at the entrance to the diversion chamber created a great amount of spray. With all the gates closed, splashing occurred during certain ranges of discharges; however, the flow over the slot was more satisfactory than when the gates were opened. A splash cover was installed over the slot, which minimized the objectionable spray.

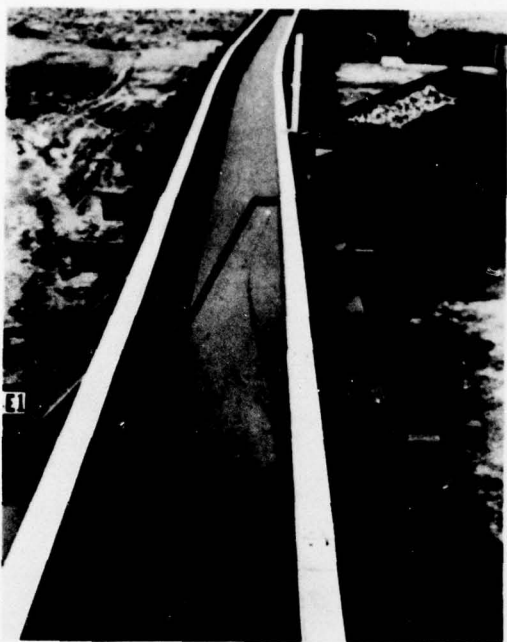
Photo A1. Looking downstream at diversion slot

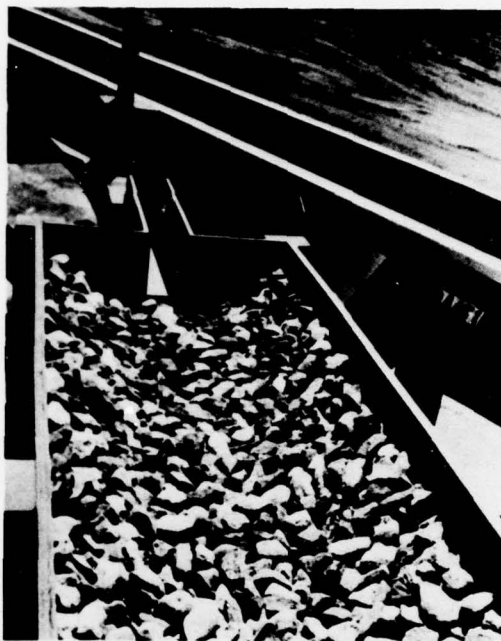
Photo A2. Close-up of diversion channel

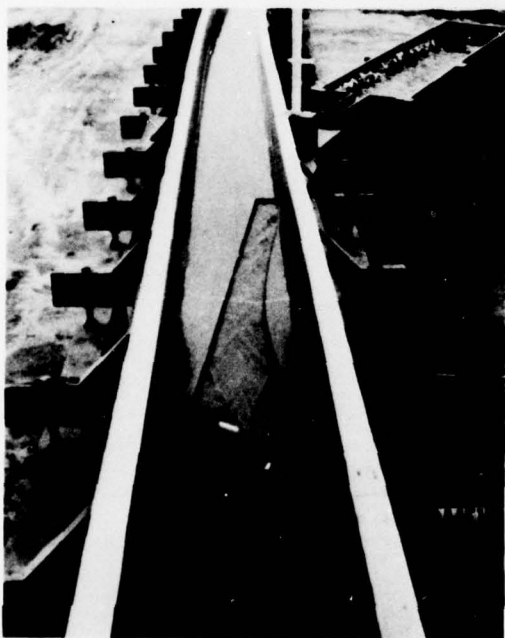
Photo A3. Looking downstream with diversion gate open,  
 $Q = 100$  cfs

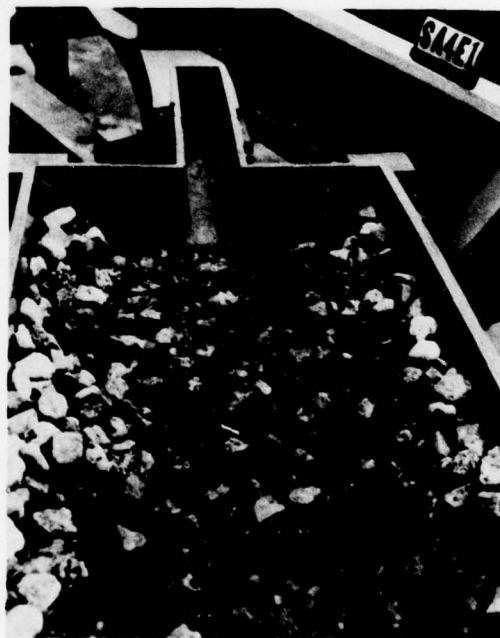
Photo A4. Looking upstream with diversion gate open at flow entering diversion channel,  
 $Q = 100$  cfs

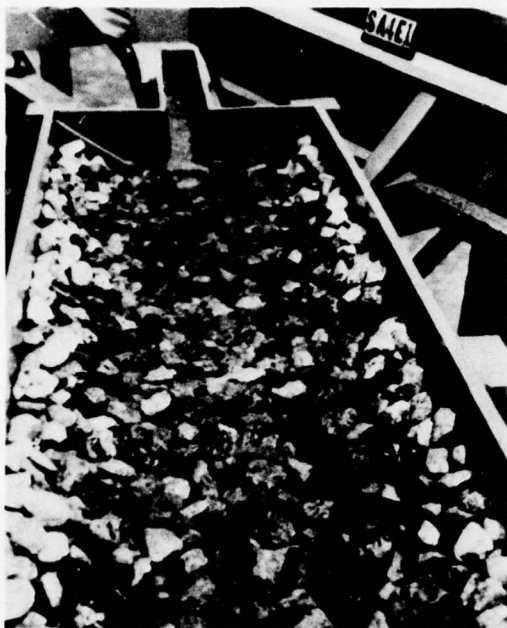
Photo A5. Looking upstream at flow entering diversion channel with gate open,  $Q = 125$  cfs

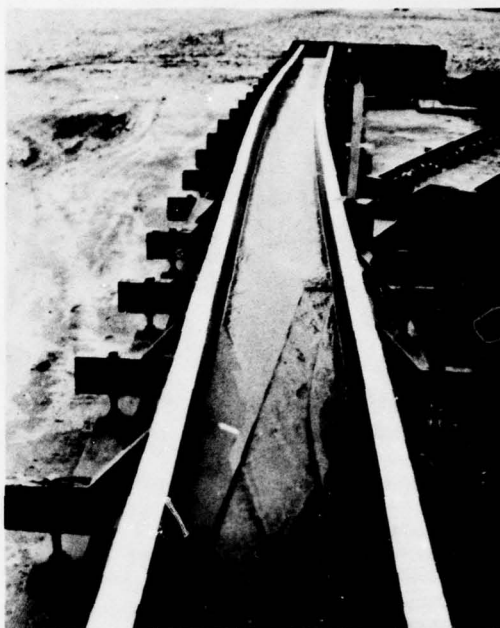
Photo A6. Looking downstream with diversion gate open,  $Q = 125$  cfs

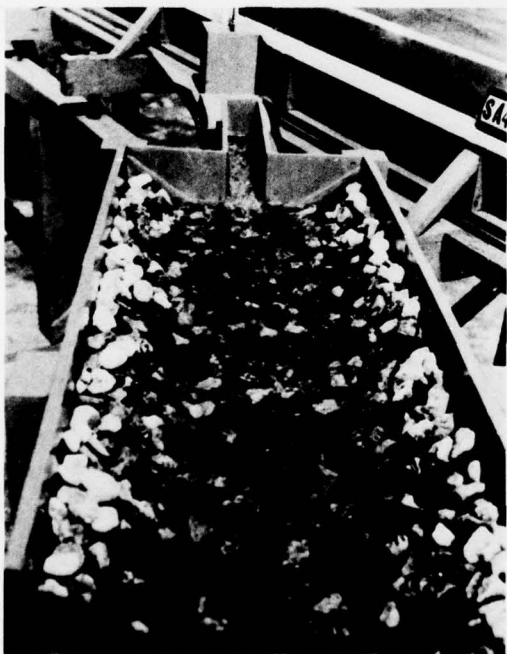
Photo A7. Looking upstream at flow entering diversion channel with diversion gate partially open to pass 100 cfs.  $Q = 500$  cfs in main channel

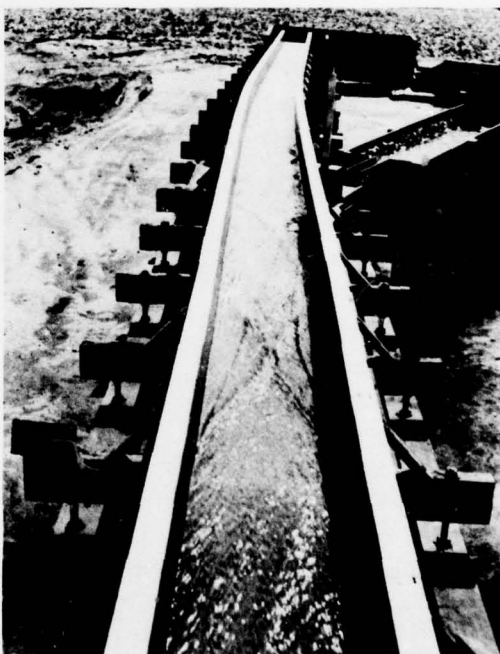
Photo A8. Looking downstream at flow past slot,  $Q = 500$  cfs. Diversion gate partially open to pass 100 cfs

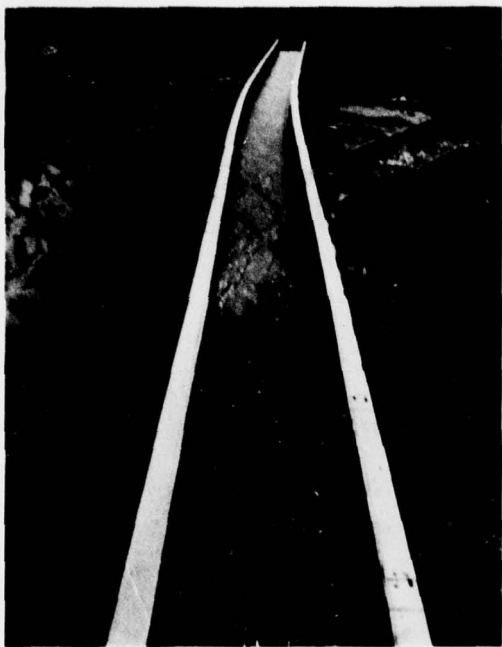
Photo A9. Looking downstream at  
flow past slot with diversion  
gate open,  $Q = 500$  cfs

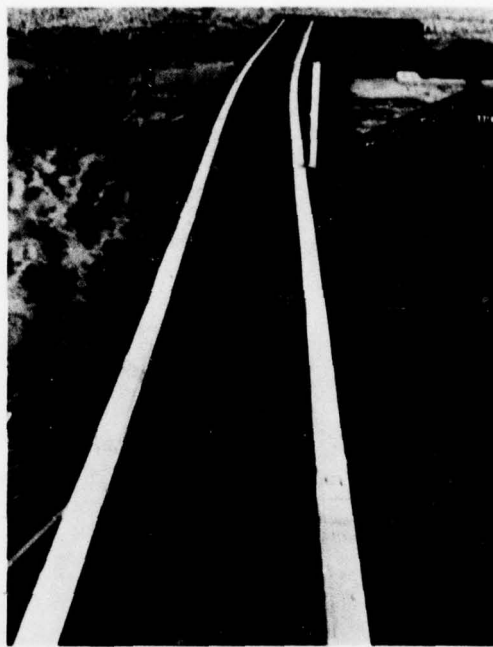
Photo A10. Looking downstream at  
flow past slot with diversion  
gate open,  $Q = 2,000$  cfs

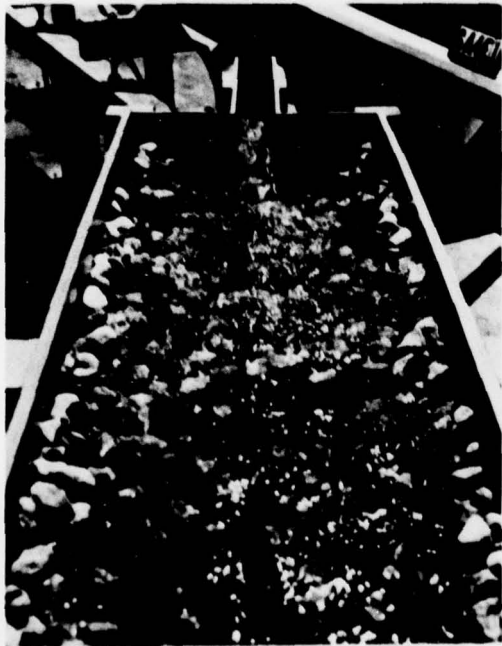
Photo A11. Looking upstream at  
flow entering diversion channel  
with diversion gate fully open,  
 $Q = 260$  cfs.  $Q = 2,000$  cfs in  
main channel

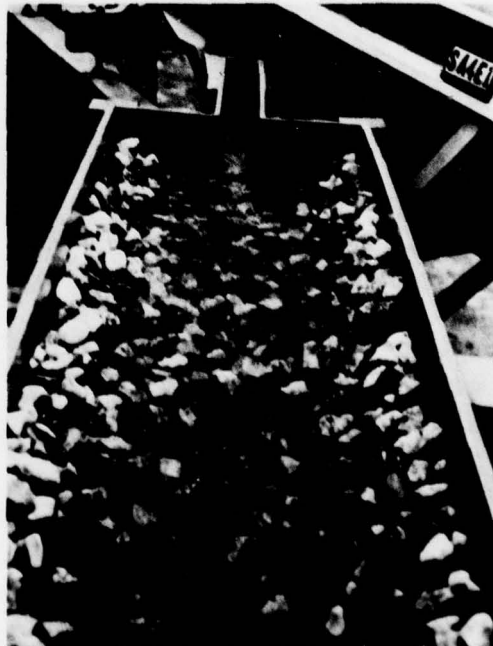
Photo A12. Looking upstream at  
flow entering diversion channel  
with diversion gate partially  
open to pass 100 cfs.  $Q = 5,000$   
cfs in main channel

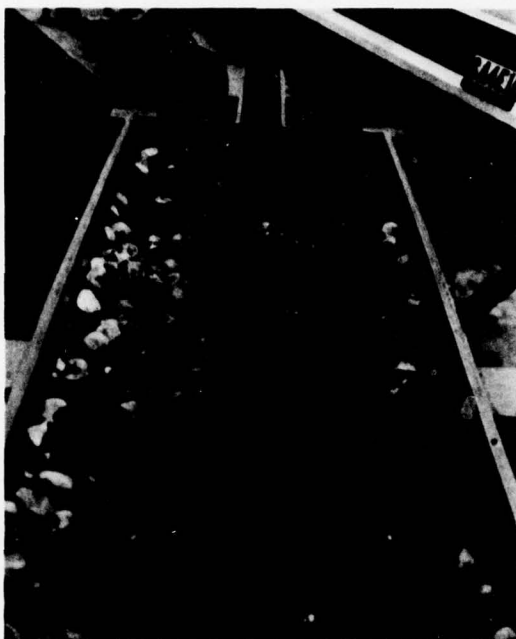
Photo A13. Looking upstream at flow entering diversion channel with diversion gate open,  $Q = 300$  cfs.  $Q = 5,000$  cfs in main channel

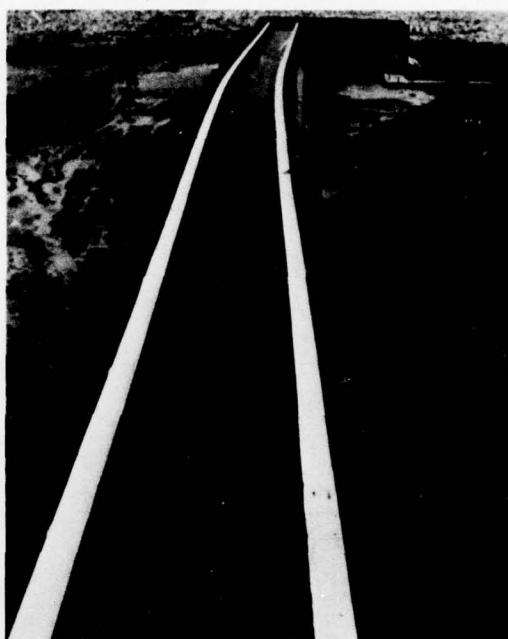
Photo A14. Looking downstream at flow slot with diversion gate open,  $Q = 5,000$  cfs

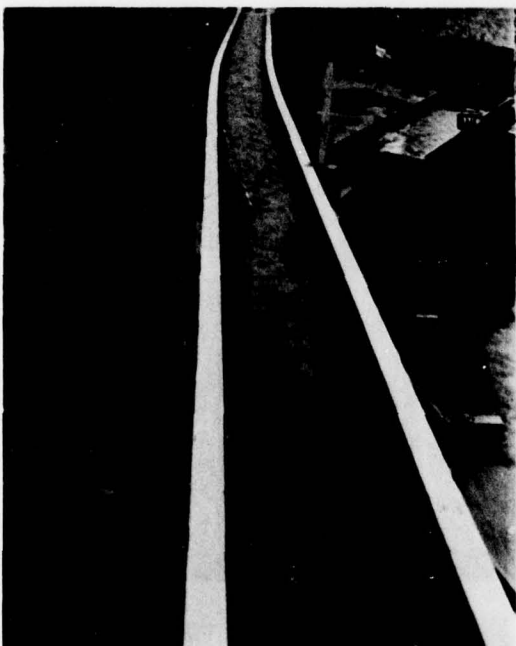
Photo A15. Looking downstream at flow past slot with diversion gate open,  $Q = 8,600$  cfs

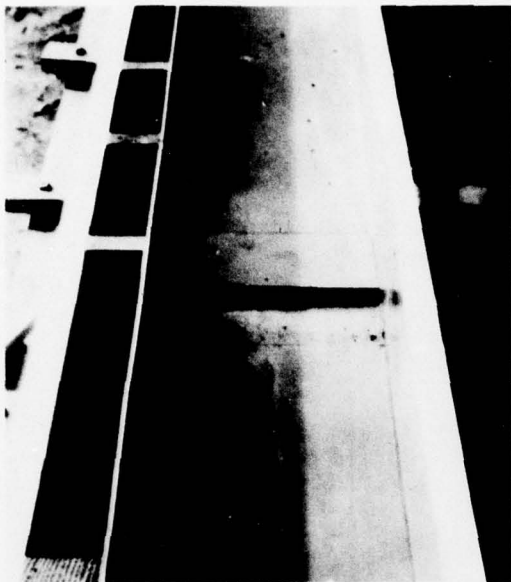
Photo A17. Looking downstream at entrance to diversion structure

8. The main problems of concern were the flow distribution in the curved portion of the diversion channel under the main channel invert and the influence of the curved approach upon the discharge through the gate well. The investigation showed that for most of the discharges, flow conditions in the curved sections and in the section downstream from the gate well were generally satisfactory. The tests were conducted by establishing a sequence of discharges and setting the gate opening to divert a certain discharge. The slot inlet intercepted a maximum discharge of 350 cfs before any flow would continue down the main channel. For flows greater than 350 cfs, with the gate opened and closed, waves were set up in the channel by the slot inlet in the invert that created a spray which covered a wide area. The spray ceased to exist when the discharge in the main channel was greater than 1,000 cfs. A gage installed on the cover of the gate well indicated a maximum pressure head of 15 ft. Visual results at various discharges are shown in Photos A17-A31.

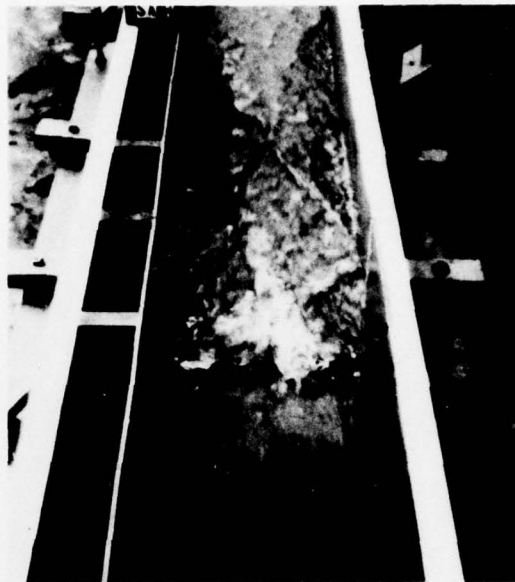
Photo A18. Looking downstream at entrance to diversion structure with 300 cfs in main channel with diversion gate closed. A 6-ft-high splash occurred at the center of the channel and the entrance to the diversion structure

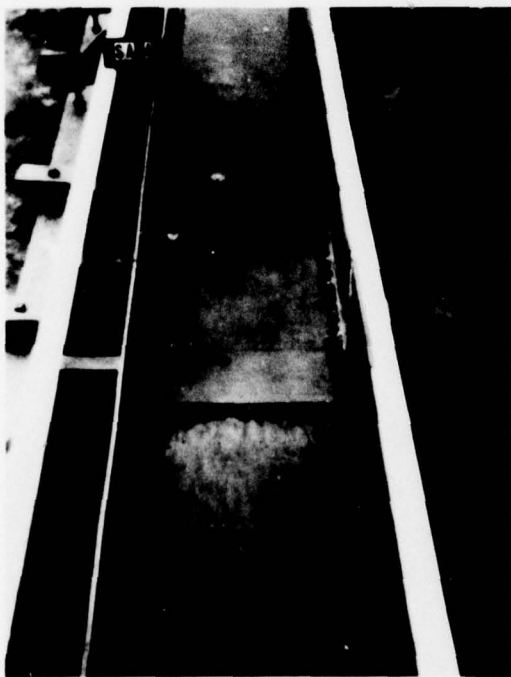
Photo A19. Looking downstream at 300 cfs passing through entrance to diversion structure with gate fully open

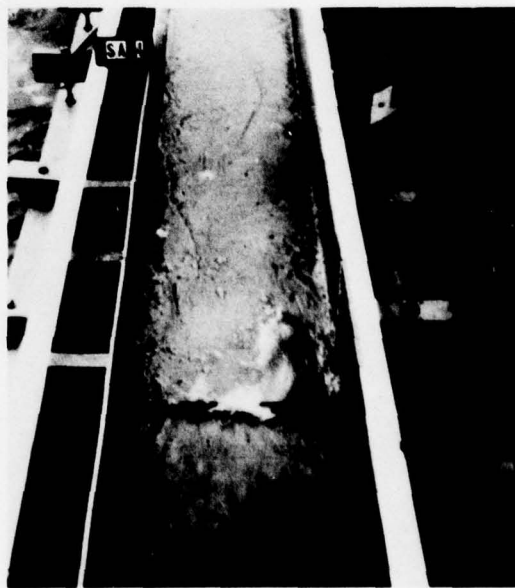
Photo A20. Looking downstream. 400 cfs in main channel, with 350 cfs flowing into the diversion structure with gate fully open

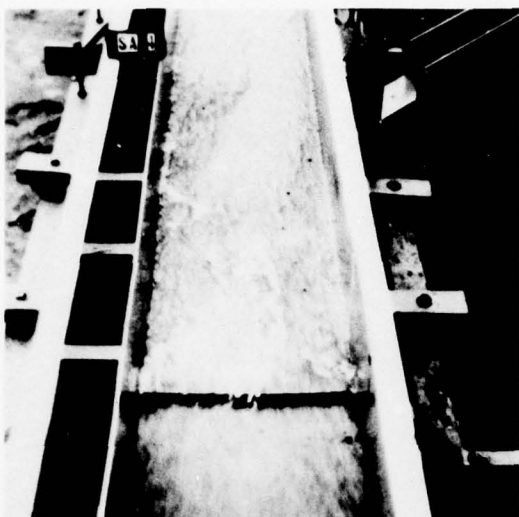
Photo A21. Looking downstream.  
500 cfs in main channel, with  
375 cfs flowing into the diver-  
sion structure with gate fully  
open

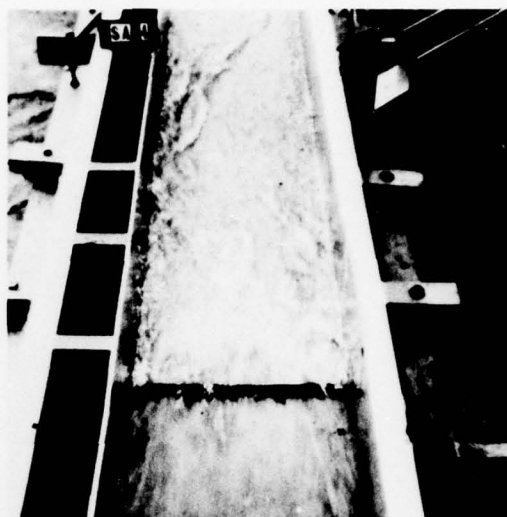
Photo A22. Looking downstream.  
600 cfs in main channel, with  
400 cfs flowing into the diver-  
sion structure with gate fully  
open. A heavy spray 15 ft high  
occurred at the entrance of the  
diversion structure with even  
distribution across channel

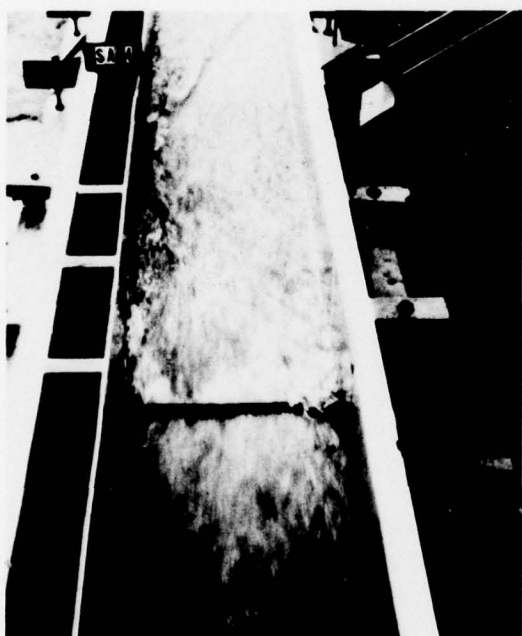
Photo A23. Looking downstream.  
700 cfs in main channel, with  
425 cfs flowing into the diver-  
sion structure with gate fully  
open. Balance passing down  
main channel. A heavy spray  
15 ft high occurred at the en-  
trance of diversion structure,  
evenly distributed across channel

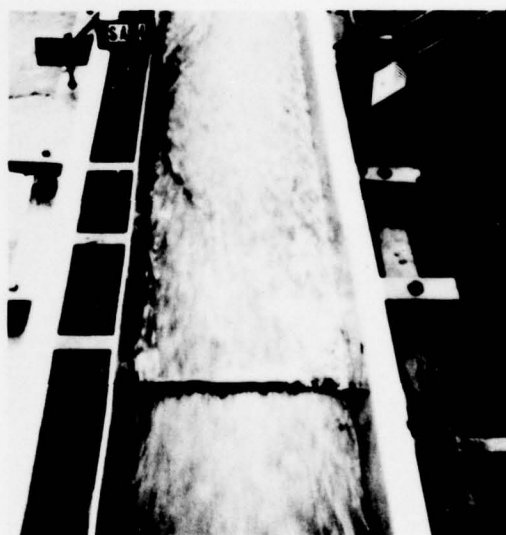
Photo A24. Looking downstream.  
800 cfs in main channel, with  
450 cfs flowing into the diver-  
sion structure with gate fully  
open. Heavy spray 15 ft high  
at right wall

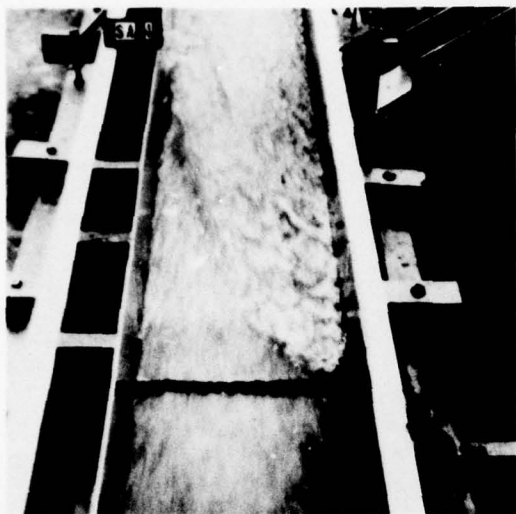
Photo A25. Looking downstream. 900 cfs in main channel, with 450 cfs flowing into the diversion structure with gate fully open. A disturbance occurred at right wall over entrance, creating cross waves downstream toward left wall

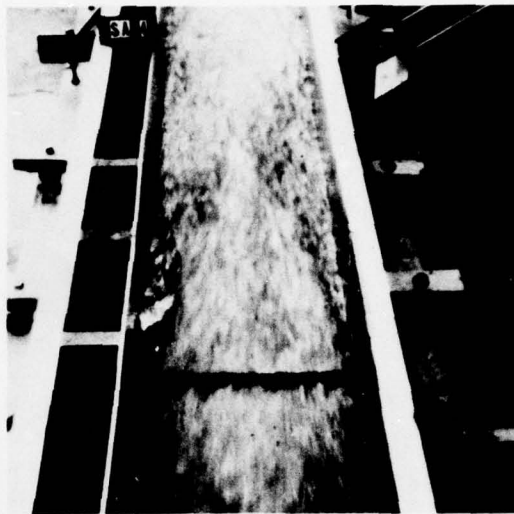
Photo A26. Looking downstream. 1,100 cfs in main channel, with 300 cfs flowing into the diversion structure controlled by diversion gate. A 3-ft-high wave occurred along left wall downstream of entrance

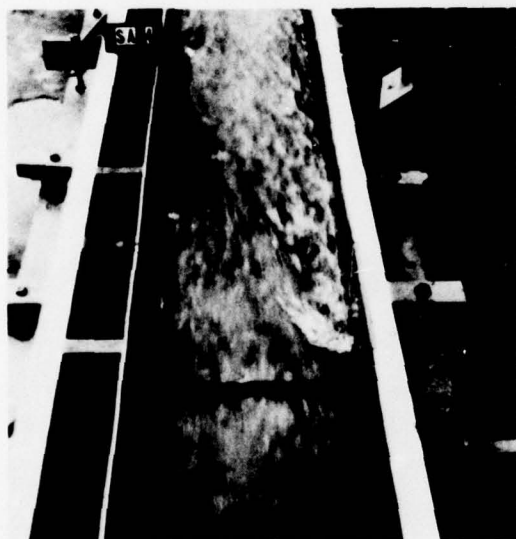
Photo A27. Looking downstream. 1,100 cfs in main channel with 300 cfs flowing into the diversion structure

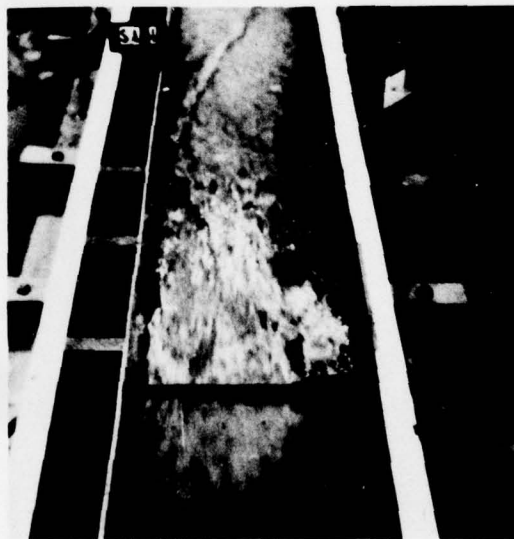
Photo A28. Looking downstream. 700 cfs in main channel, 400 cfs flowing into the diversion structure. A spray of 15 ft high occurred at entrance of diversion structure and formed a cross wave downstream from right wall toward left wall
